Manhole Inspection Summary

Manhole # S43OO_003MH

Insp Date: **12/11/07 8:22 AM**

Location Address: **Clough-25th**

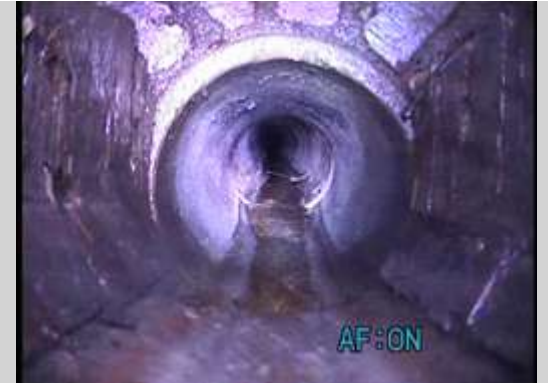
12 O'Clock Outflow

8 in. Circular Gravity Sewer
Pipe Out @ 12 O'Clock

Pipe Height: **8.4** (in.) Rod and Bar (Angled)
Pipe Material: **Clay** ☐ Pipe Lined
Invert Depth: **8.50** (ft.) Flow Characteristics: **Fast**
Deposits: ☒ None ☐ Mud ☐ Sludge ☐ Debris ☐ Grease
Silt Depth: (in.) Deposits Extent:
Infiltration: **None** Pipe Seal Cond: **Sound**

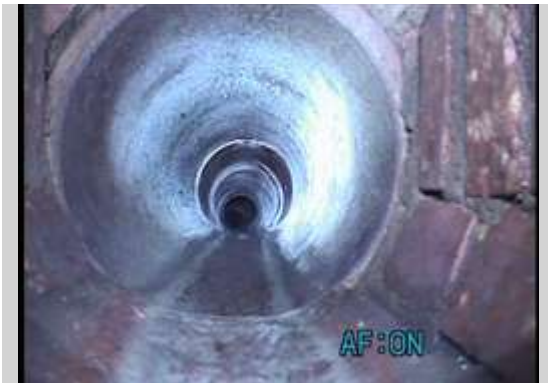
6 O'Clock Inflow

8 in. Circular Gravity Sewer
Pipe In @ 6 O'Clock

Pipe Height: **8.4** (in.) Rod and Bar (Angled)
Pipe Material: **Clay** ☐ Pipe Lined
Invert Depth: **8.00** (ft.) Flow Characteristics: **Fast**
Deposits: ☒ None ☐ Mud ☐ Sludge ☐ Debris ☐ Grease
Silt Depth: (in.) Deposits Extent:
Infiltration: **None** Pipe Seal Cond: **Sound**
